PROPERTY INSPECTION REPORT

Prepared For: Joe & Jane Homebuyer
(Name of Client)

Concerning: 11615 Sweetwater Trl. Austin, TX 78750
(Address or Other Identification of Inspected Property)

By: Jesse Bryant TREC License #8511 2/10/09
(Name and License Number of Inspector) (Date)

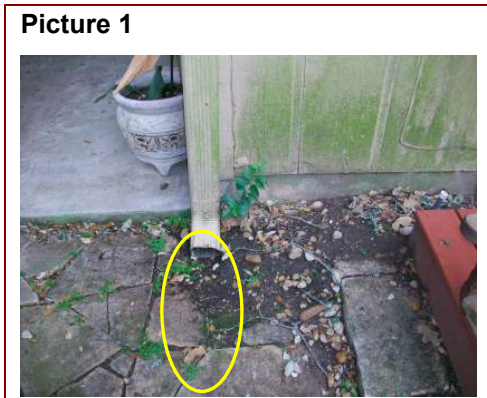
- Some of the gutter downspouts are lacking a splash block or a downspout extension (**pic 1**). All gutter downspouts should discharge water at least 3 – 5 feet away from the foundation in order to maintain a proper level of soil moisture content around the foundation and to prevent ponding or soil erosion.
- The downspout at the Northeast corner of the house is not properly secured where two of the downspout sections connect (visible from the upper deck) and may possibly leak prior to discharging at the bottom (**pic 2**).
- The gutters are very dirty and should be cleaned (**pic 3**). Gutters that are full of debris can easily overflow and cause potential water damage to nearby walls, soil erosion and may even become loose at the roof fascia trim. There is a section of the rear gutter over the kitchen window that is sagging. Cleaning and re-securing are recommended.

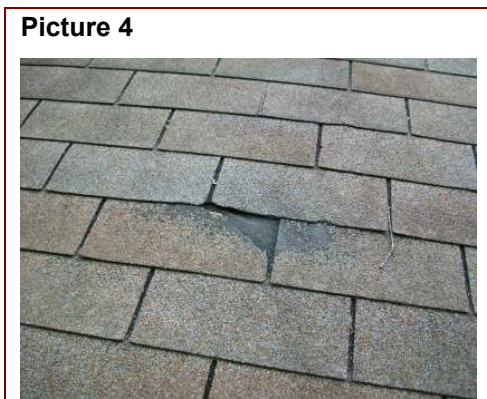
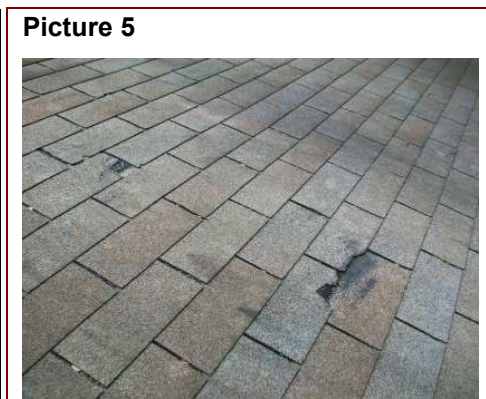
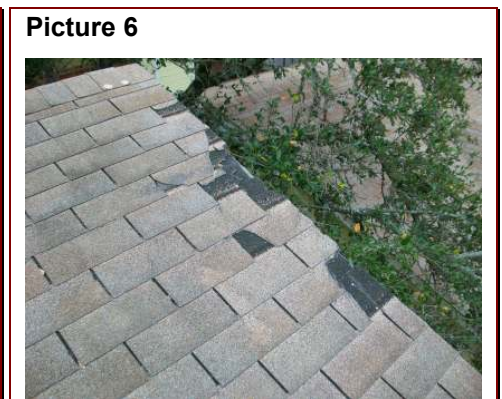
- All tree limbs in close proximity to the roof should be kept trimmed approximately 2 feet above and away from the roof surface in order to prevent insect intrusion and possible shingle damage during periods of high winds. Multiple areas of shingle damage are present at this time and should be repaired (**pic 4-6**).

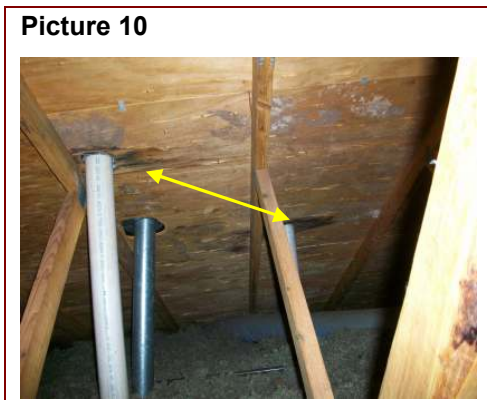
- Evidence of roof leakage was observed at the plumbing vent pipes where they pass through the roof (*pic 10*). Repairs are needed at the plumbing vent pipe roof jacks.
- Ideally, the attic access hatch should be better insulated for improved efficiency.
- There are some sections of vertical wall insulation (North wall for the upstairs living room, visible in the chimney chase) that are missing and have fallen down to the fireplace area below (*pic 11*). This insulation should be removed from around the fireplace and new insulation should be installed where missing for improved efficiency.
- The bottom chord of one of the roof trusses has been cut to make room for the recently installed cooling equipment in the heater closet (*pic 12*). Structural wood trusses should not be damaged, cut or modified without prior approval by an engineer of the truss manufacturer.

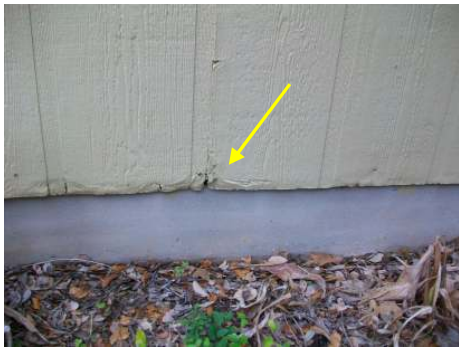
Picture 13

- There are various sections of damaged siding around the house, particularly near the bottom edges of the siding panels (**pic 13-15**). Various types of hardboard siding are subject to rot and deterioration unless properly maintained with caulking and exterior paint. Once repairs have been made to the damaged sections, it is recommended that you inspect the siding material annually and make repairs as necessary in order to maintain this product.

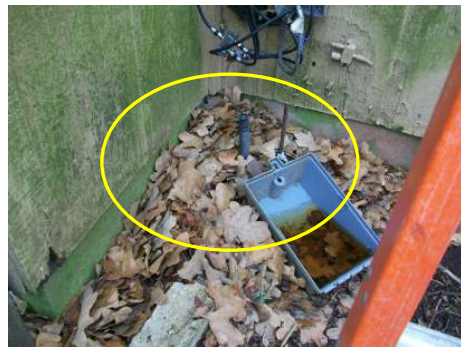
Picture 16

- ◇ *FYI: Soil vegetation and wood/leave debris that is too close to the siding presents a condition that is conducive to possible wood-destroying insect activity (**pic 16**). There should be at least 6 inches of clearance from the siding to any soil, brush, or leaf piles. It is also recommended that at least a 1 inch gap be provided between the wood fence material and the siding/trim material*

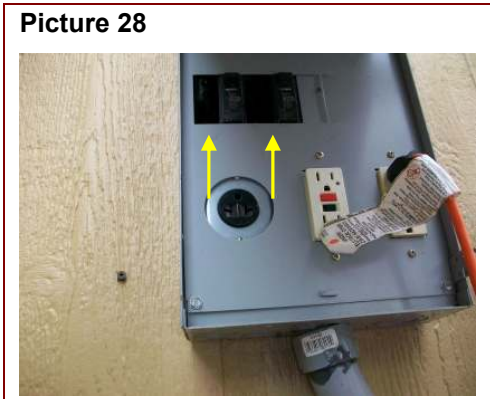
- The deadfront cover of the upper sub panel box, at the North exterior, is missing some of the fill plates. All openings in a panel box’s deadfront cover are to be covered with the appropriate plastic fill plate (not tape) for improved safety (pic 28).

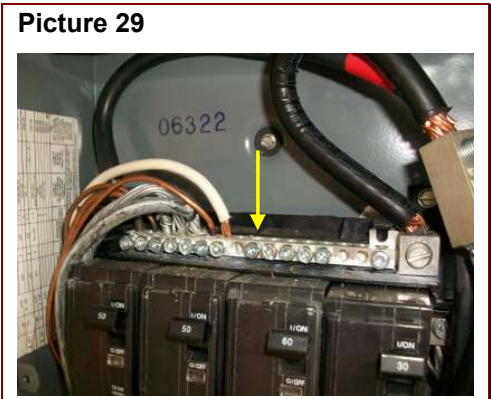
- It is recommended that the exterior sub panel boxes be sealed to the exterior wall in order to prevent possible water penetration.
- There is no visible bond screw or strap in the lower sub panel at the North side of the house (pic 29). This panel box needs to be properly bonded to the grounding system.

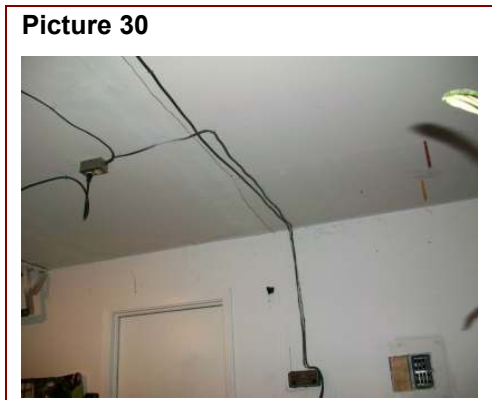
- The wiring exposed on the interior walls of the garage should be relocated or protected by a rigid conduit if there is a chance that they will be subject to damage (impact damage from storage items, tools, etc.) **(pic 30)**.

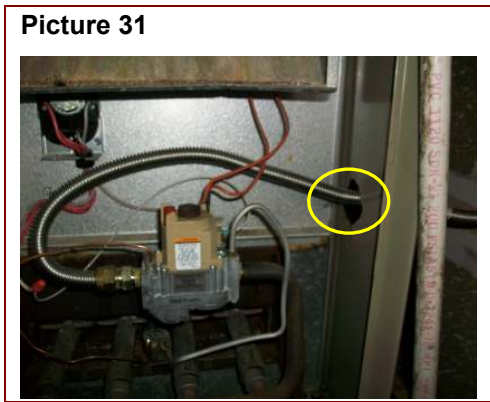
- The gas line running into the heating unit is a flexible connector line (**pic 31**). Current standards prohibit flexible gas connectors from extending through appliance housings as this configuration can cause damage to the flexible connector. It is recommended that hard pipe be run into the heating unit in order to prevent damage to the flexible connector as a result of unit vibration. At a minimum, some type of dense pipe insulation could be used to isolate the flexible connector from the heater housing.

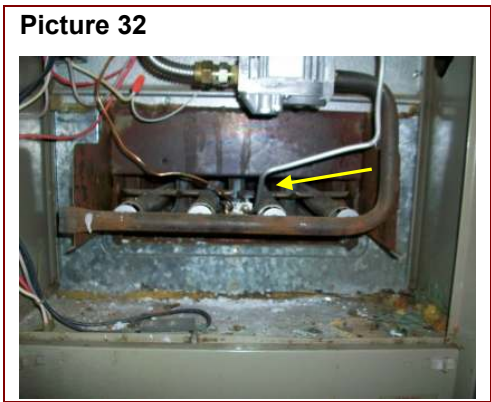
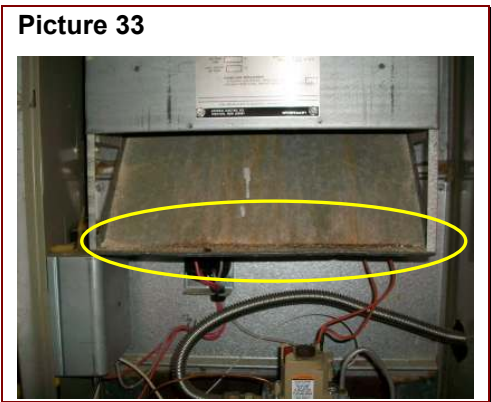
- There is a significant amount of rust inside the visible portions of the heat exchanger as well as at the burner assemblies (**pic 32-33**). Based on the age of the unit and the amount of rust contained inside, it is likely that the heat exchanger may have some type of crack or pinhole that could allow combusted gases to mix with the distribution air that blows across the exterior portion of the heat exchanger. The only way to positively identify a crack in the heat exchanger would be to disassemble the heating unit in order to observe the entire heat exchanger; a procedure that is well beyond the scope of this inspection. It is recommended that you consult with a licensed heating and cooling technician in order to explore replacement options as heat exchangers of this age and condition can rarely be repaired.

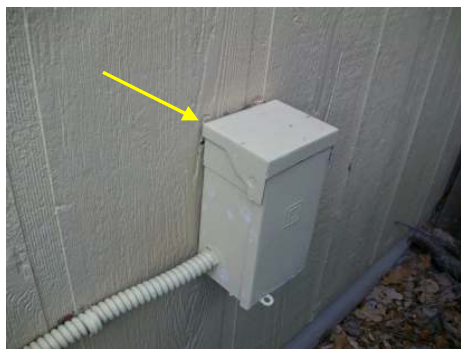
Picture 34

- It is recommended that the electrical disconnect box near the AC condenser unit be sealed to the exterior wall in order to prevent possible water penetration (*pic 34*).

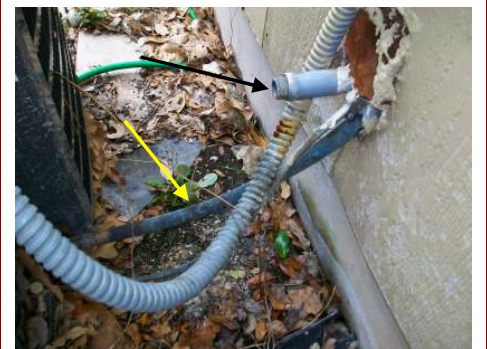
Picture 36

- Damaged insulation on the refrigerant lines at the outdoor unit should be repaired for improved efficiency and to prevent condensation on the outside of the line (*pic 36 yellow arrow*).

- The discharge location of the condensate line for the air conditioning system should be improved. The primary condensate line should discharge at least 3 – 5 feet away from the structure in order to prevent excessive soil moisture near the foundation (*pic 36 black arrow*).

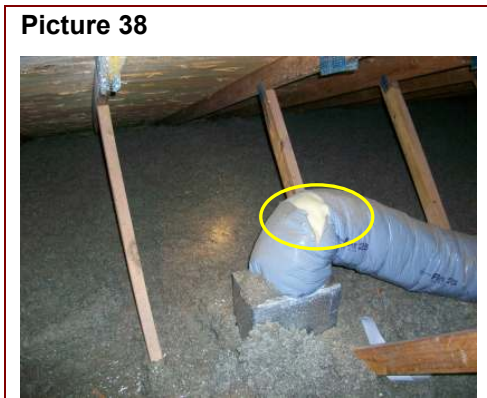
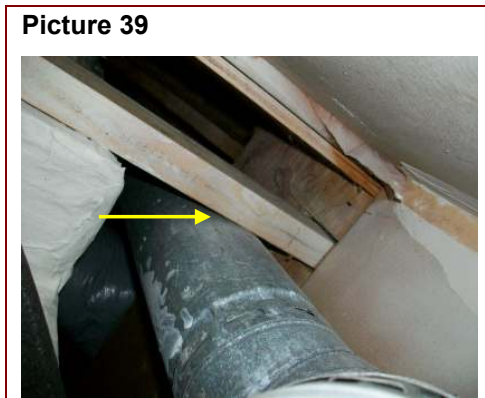
- The heater vent pipe is currently in direct contact with combustible materials (wood framing, refrigerant line insulation) and there is a section of the heater vent pipe that has become disconnected (**pic 39-40**). Repairs to the heater vent pipe are recommended for improved safety.

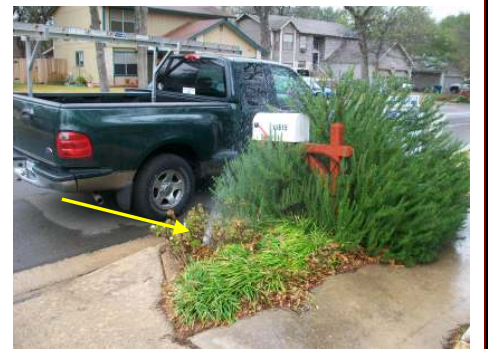
Picture 52

- The water spray from the sprinkler heads should be re-directed away from the structure and/or any fencing, decks, etc., to decrease the possibility of damage (especially at the South side of the house) (pic 50).
- The rain detection device at the back fence is loosely secured and some of the wiring leading to the device is damaged. Repairs are recommended to ensure that the device operates properly (pic 51).
- One of the heads on zone 1, closest to the driveway, is spraying improperly and may need to be adjusted so that it can seat and spray properly when activated (pic 52).
