PROPERTY INSPECTION REPORT

Prepared For: Joe & Jane Homebuyer
(Name of Client)

Concerning: 11615 Sweetwater Trl. Austin, TX 78750
(Address or Other Identification of Inspected Property)

By: Jesse Bryant TREC License #8511 2/10/09
(Name and License Number of Inspector) (Date)

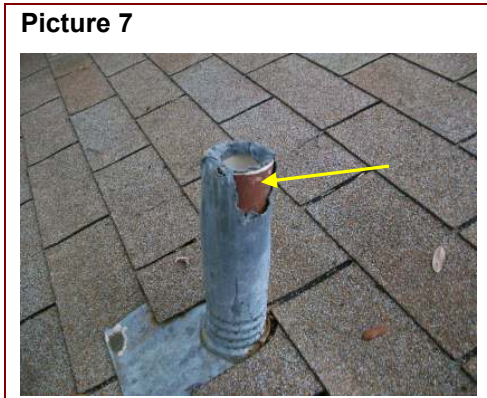
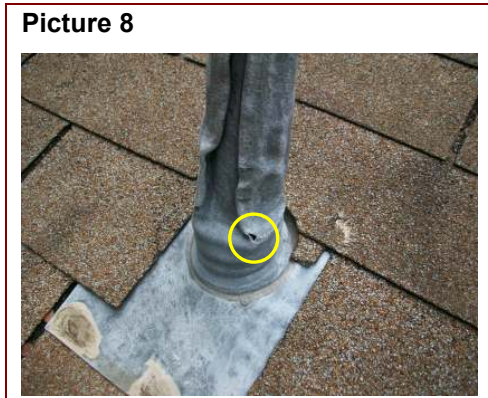
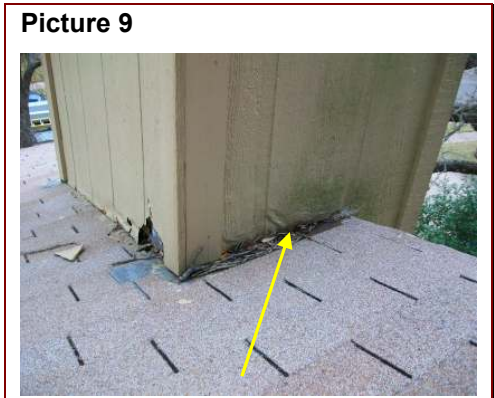
- Many of the lead roof jacks around the plumbing vent pipes are damaged and in need of replacement as they can allow water penetration into the attic (**pic 7-8**).

- The flashing on the backside of the chimney can allow water to collect behind the chimney and there is evidence of leakage at this flashing, visible from the attic (**pic 9**). Flashing improvements are recommended at this location in order to prevent continued water penetration into the chimney structure as well as additional siding damage.

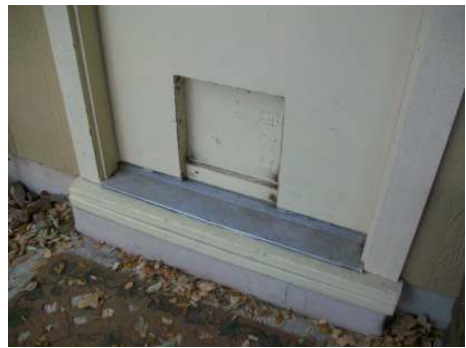
Picture 17

- The keyed deadbolt at the rear exterior door (dining room) should be changed out to a deadbolt that utilizes a hand operated throw at the interior. Keyed deadbolt locks can be a safety hazard if emergency escape is required and the key cannot be located.
- The rear garage exterior door has a hole cut out (likely for a pet door) that has been previously patched (**pic 17**).
- The lock on the sliding glass door, in the master bedroom, does not latch properly and is inoperative.
- The heater closet door is damaged at the upper corner and catches on the door frame when opened and closed.
- The sliding screen door, at the master bedroom, is damaged/torn.
- The 8-1/4 inch step at the sliding glass door, from the lower patio into the master bedroom, exceeds the maximum step height allowed (7-3/4 inch) and may present a possible trip hazard.

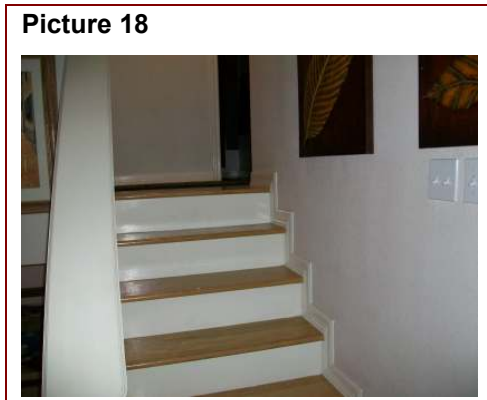
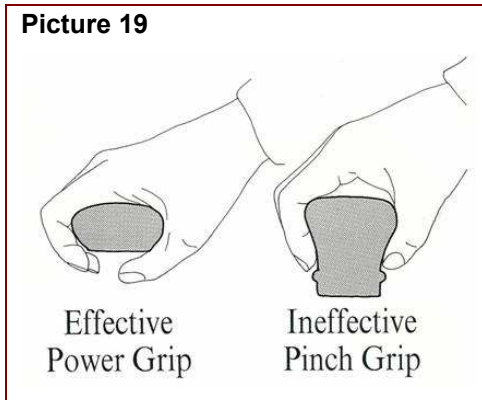
- A graspable handrail is required at the steps between the first and second story. The handrail must be between 1-1/4 inches and 2 inches wide and there must be at least a 1-1/2 inch gap between the handrail and wall (**pic 18-19**). All handrail ends should also turn back and terminate at the wall surface in order to prevent snags and tripping.

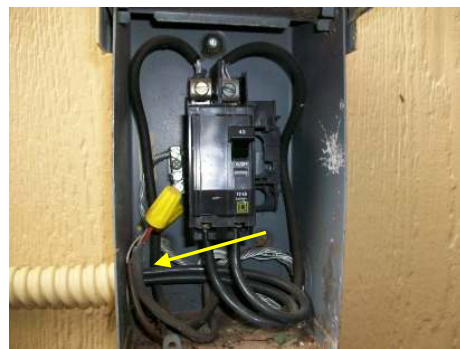
Picture 35

- The thermostat/control wiring for the downstairs unit has been routed inside the conduit that also protects the electrical supply wiring (*pic 35*). The thermostat control wiring needs to be routed to the outdoor condenser independent of the electrical wiring.

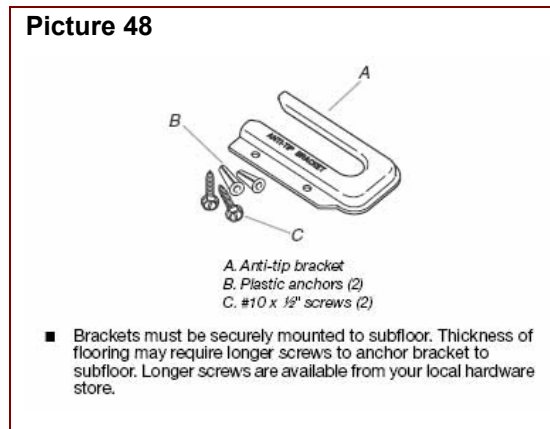
- An anti tip device is required at the range for increased safety. This is simply a strap or metal bracket attached between the range and the wall to prevent the range from tipping forward if a child were to open and stand on the oven door (**pic 48**).

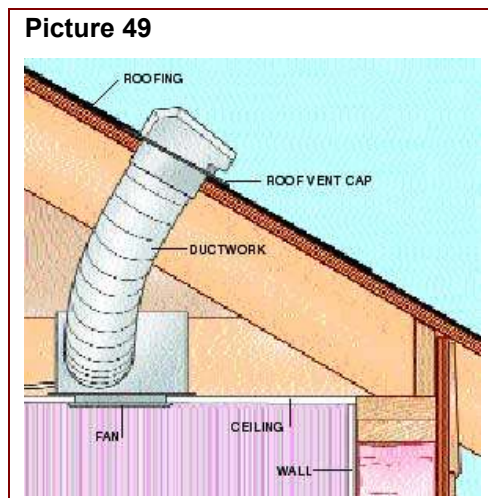
- G. Mechanical Exhaust Vents and Bathroom Heaters – Comments:**
- There is no mechanical exhaust vent in the upstairs bathroom. All bathrooms are required to have either a mechanical exhaust fan that vents to the building exterior or an operable window to the exterior (**pic 49**). This bathroom currently has neither option. Improvements are recommended in order to prevent moisture and mildew issues in the bathroom.

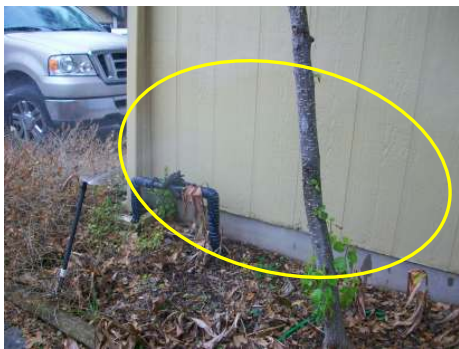
Picture 50

- The water spray from the sprinkler heads should be re-directed away from the structure and/or any fencing, decks, etc., to decrease the possibility of damage (especially at the South side of the house) (pic 50).
- The rain detection device at the back fence is loosely secured and some of the wiring leading to the device is damaged. Repairs are recommended to ensure that the device operates properly (pic 51).
- One of the heads on zone 1, closest to the driveway, is spraying improperly and may need to be adjusted so that it can seat and spray properly when activated (pic 52).
